# Manhole Inspection Summary

Manhole # S43M\_\_029MH

Insp Date: **6/5/08 12:03 PM**

**Location** Address: **801 caroline st**

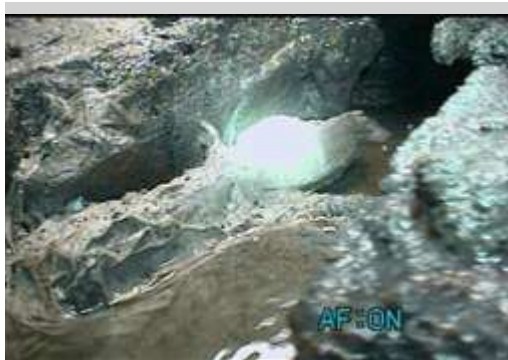
Defect 2

Condition: ☐ Sound ☐ Cracked ☐ Root Intrusion ☐ Deteriorated ☐ Leaks ☒ **Debris**

channel debris

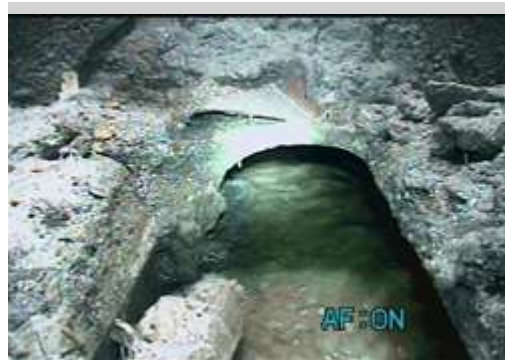
Defect 3

Condition: ☐ Sound ☐ Cracked ☐ Root Intrusion ☐ Deteriorated ☐ Leaks ☒ **Debris**

Bench condition debris

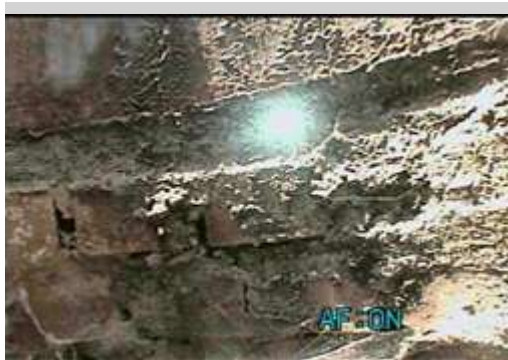
Defect 1

Condition: ☐ Sound ☐ Cracked ☐ Root Intrusion ☒ **Loose Brick** ☐ Deteriorated

chimney loose bricks

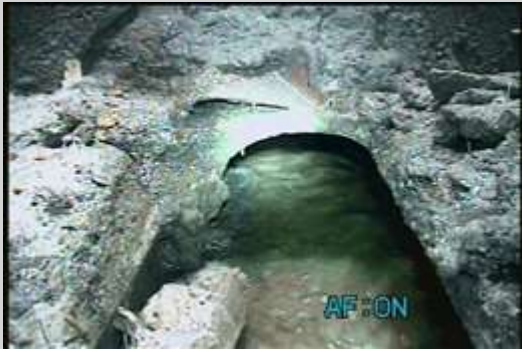
12 O'Clock Outflow

Deposits: ☐ None ☐ Mud ☐ Sludge ☒ **Debris** ☐ Grease

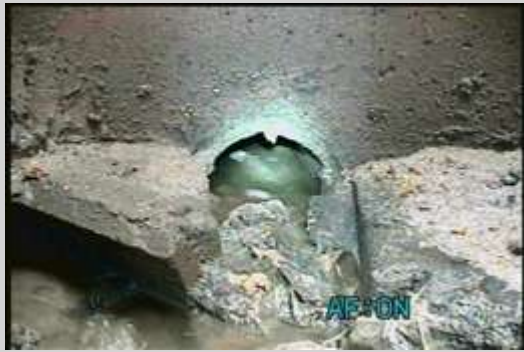
9 O'Clock Inflow

Deposits: ☐ None ☐ Mud ☐ Sludge ☒ **Debris** ☐ Grease
